COST  
ACTION C17:  
BUILT HERITAGE:  
FIRE LOSS TO  
HISTORIC  
BUILDINGS:  
FINAL REPORT

COST Action C17:  
Built Heritage: Fire Loss  
to Historic Buildings:  
Final Report

Part 2  
Appendices

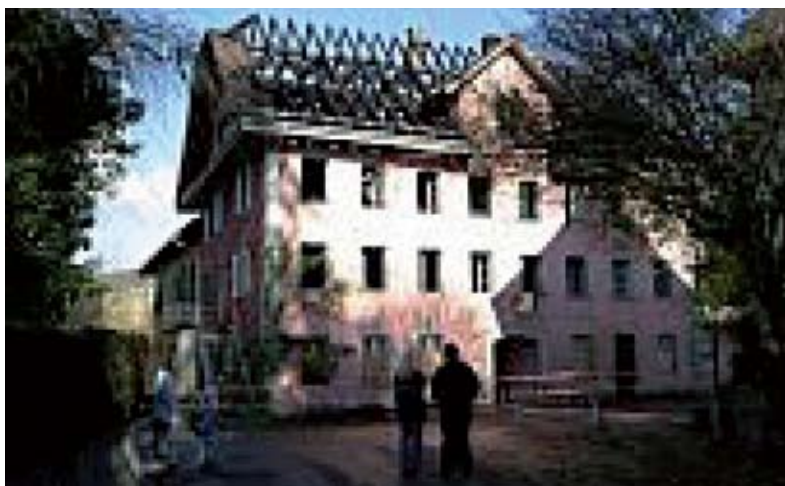
So sieht der «Löwen» nach der Brandnacht aus (Foto: mz/esw)

Drei Buben zündeten den «Löwen» an. Ein Grossfeuer zerstörte am Freitagabend die oberen Geschosse des ehemaligen Gasthofs «Löwen» in Oberrohrdorf. Verursacht wurde der Brand durch drei zeuselnde Knaben im Alter von 12 Jahren. Zwei von ihnen erlitten eine Rauchvergiftung und wurden ins Spital nach Baden eingeliefert.

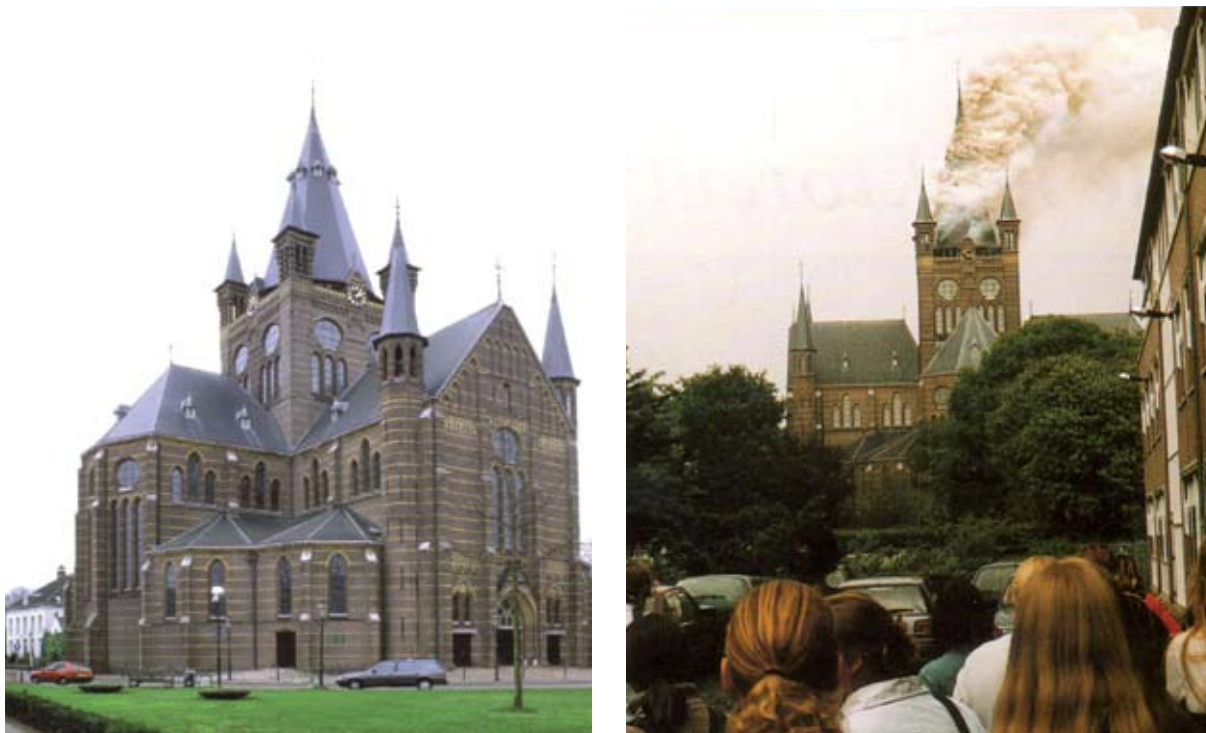
What the plumber didn't know was that a remembrance service was about to commence at 2 p.m. that afternoon, so when the bells suddenly struck up half an hour beforehand – as is the norm – he was so startled by the deafening noise that he put the burner he was working with down in its holder and went two levels down to wait for the bells to stop ringing. Anyone who's ever been in the vicinity of bells which start tolling all of a sudden will understand his reaction.

However, his second mistake was to leave the burner turned on unattended. So what happened next? As a result of the vibrations produced by the bells, the burner fell out of its holder onto the lead roofing. A mass of dust and grime had collected under the roofing, under which was a double layer of wood, which caught fire and began to smoulder. Ten minutes later or so, the plumber returned to find his burner on its side, but at that point there was no trace of any fire. After finishing his work for the afternoon, he came down to be told by bystanders that smoke was coming out of the church tower.

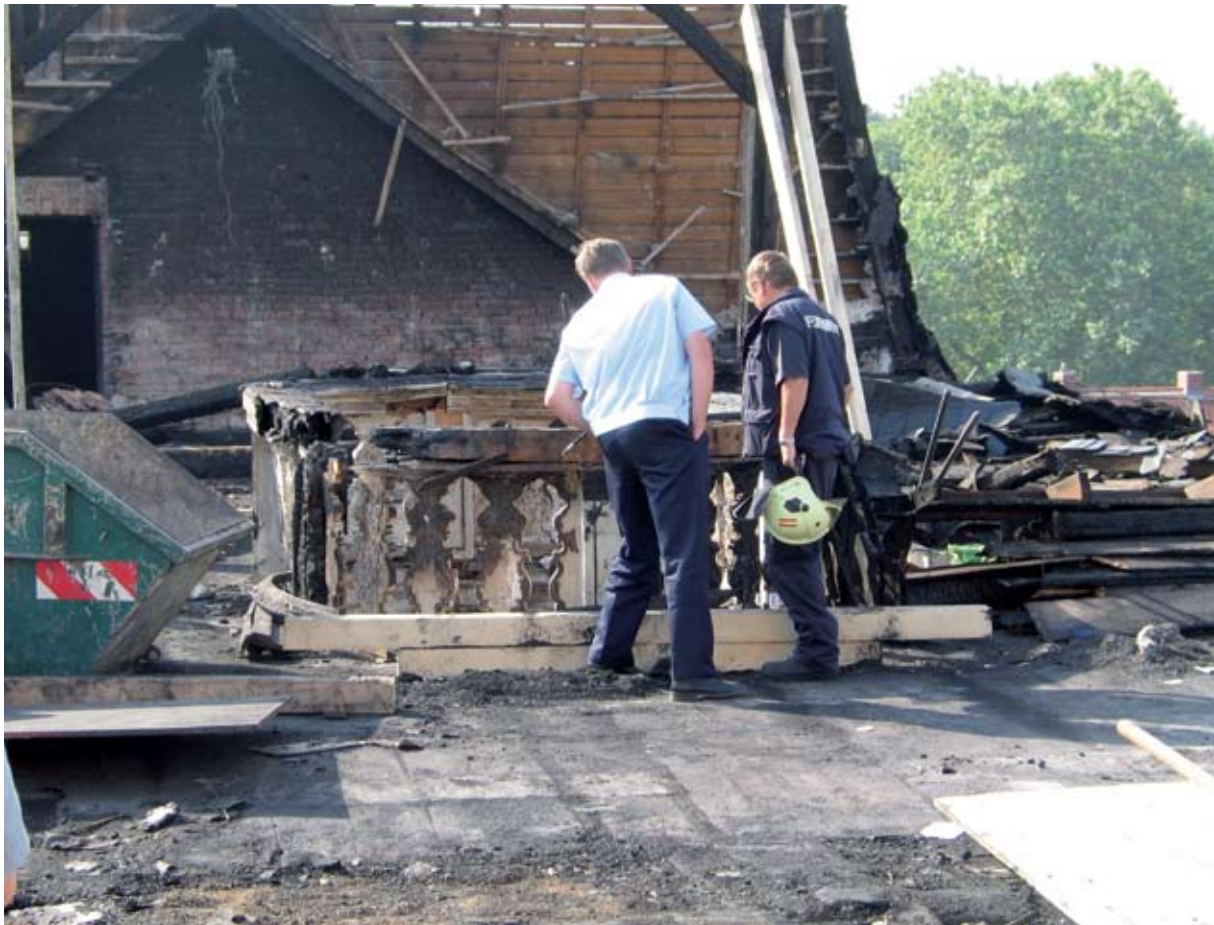
*Duchess Amalia Library, Weimar, Germany: upper level damage following fire (Photo: P Rohlén)*

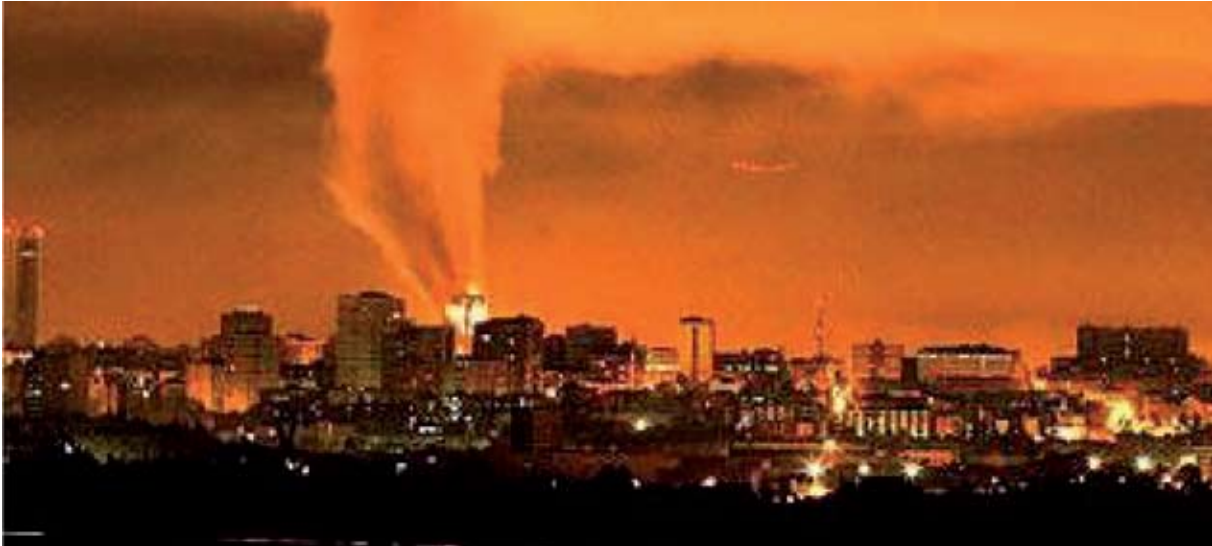
*Windsor Building during the fire* Photo source: [http://www.whatreallyhappened.com/spain\\_fire\\_2005.html](http://www.whatreallyhappened.com/spain_fire_2005.html)

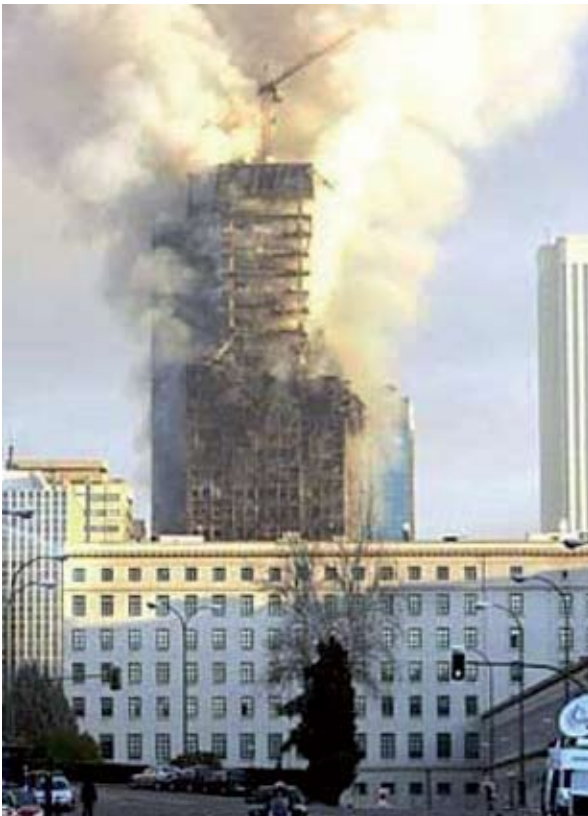
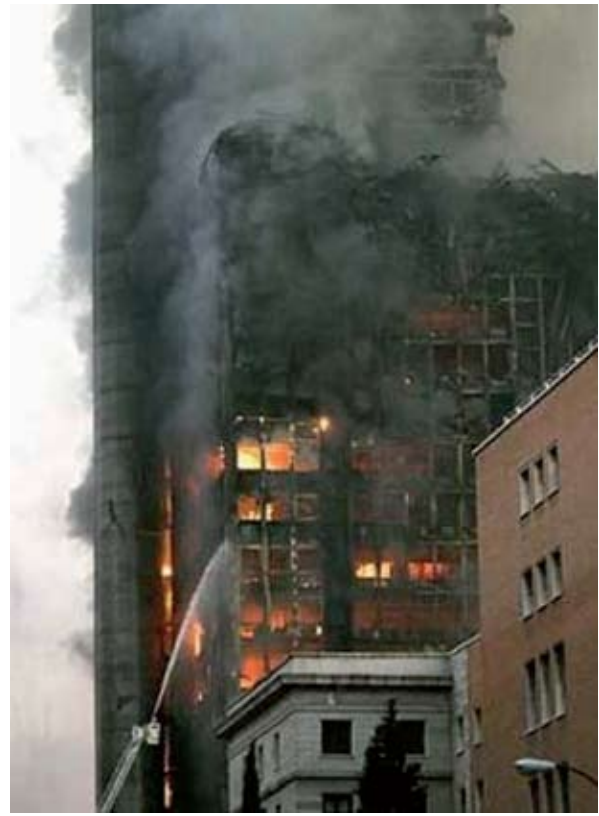
*Windsor Building during the fire* Photo source: [http://www.whatreallyhappened.com/spain\\_fire\\_2005.html](http://www.whatreallyhappened.com/spain_fire_2005.html)

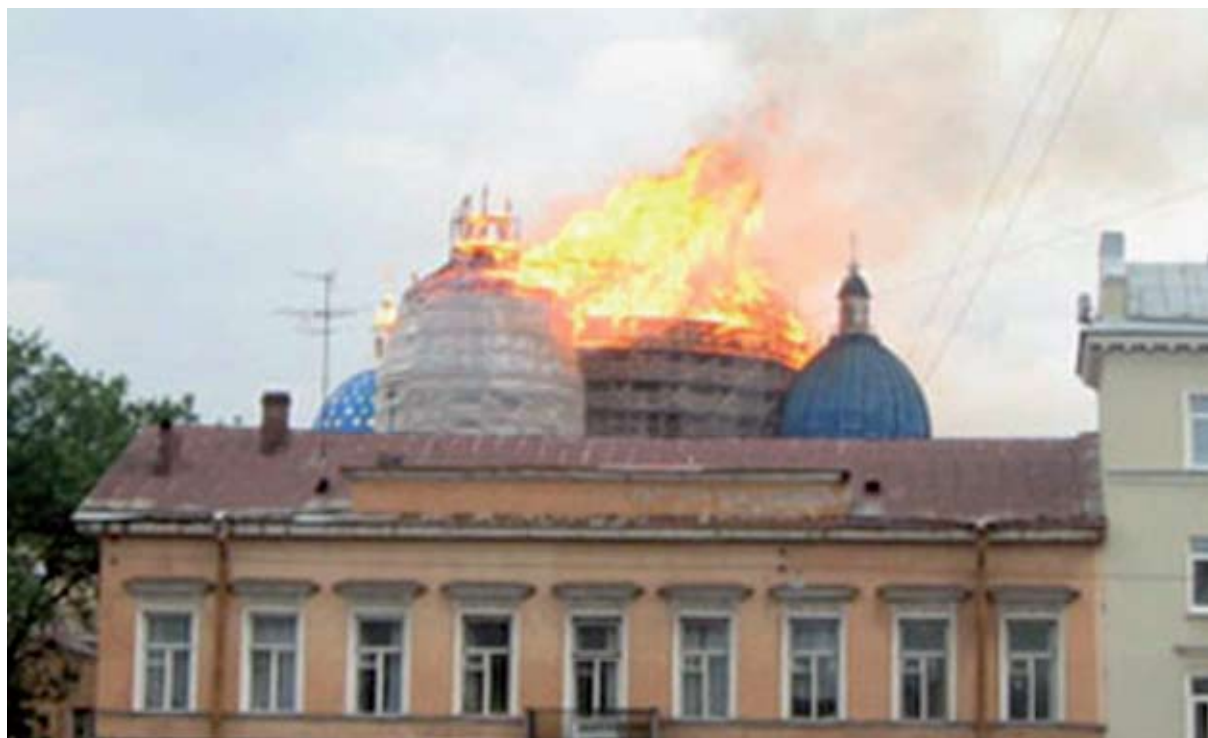
The magnificent domes of the landmark 19th-century Trinity Cathedral were all but destroyed in a blaze that erupted at the top of the stately building on 25 Aug. 2006. The restoration of the cathedral will take years, experts say.

Preliminary reports blamed the incident on builders contracted to carry out restoration works on the site. Reportedly, the fire broke out after someone had thrown a cigarette butt on the scaffolding. If those reports prove true, the firm will be held liable for the damage.

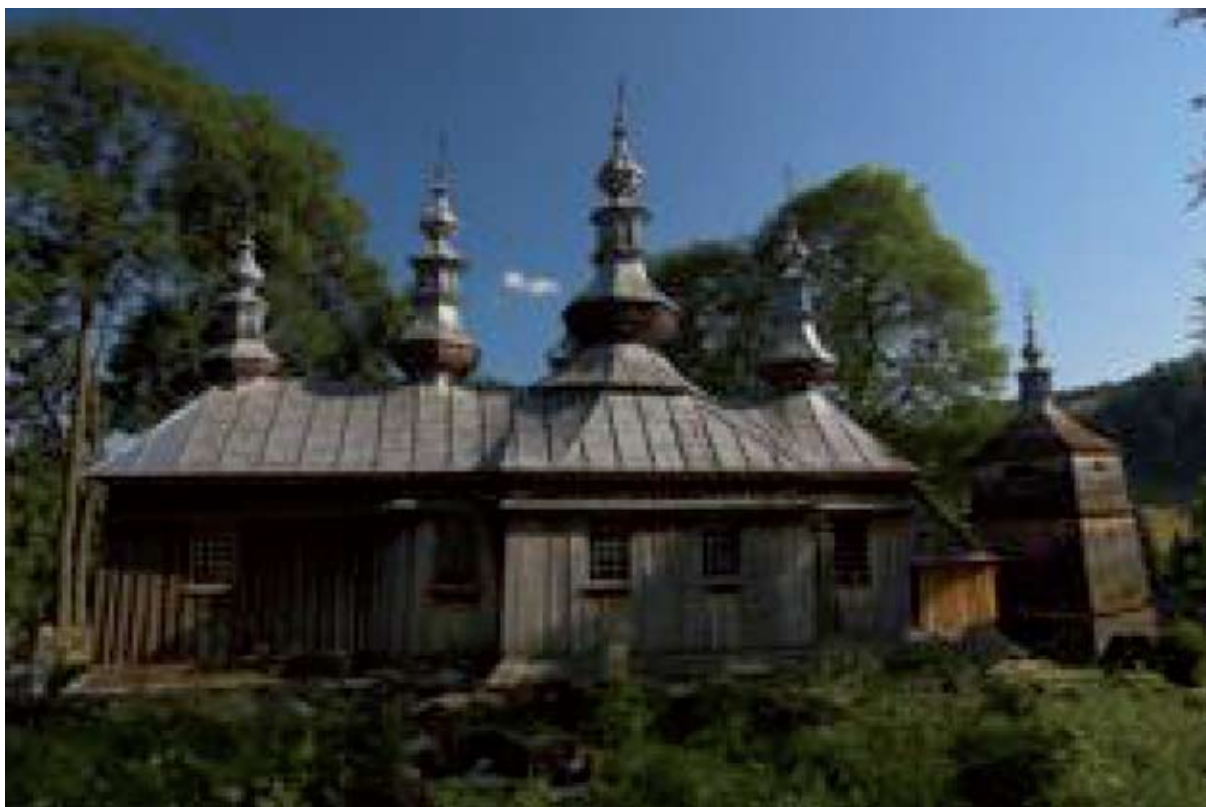
On 13th September 2006 in the Komancza settlement of the Polish Bieszczady Region (East-South part of Poland) the wooden building of the Eastern Orthodox Church, dating back to 1802, went up in flames. The antique belfry of the church was the one and only part the fire fighters rescued.

The fire probably broke out in one of the church domes. The belfry escaped destruction. The fire gutted the church building leaving only the fragment of the wall and the doors leading to the belfry. The church equipment, among it the iconostas from 1832, was destroyed.
