COST  
ACTION C17:  
BUILT HERITAGE:  
FIRE LOSS TO  
HISTORIC  
BUILDINGS:  
FINAL REPORT

COST Action C17:  
Built Heritage: Fire Loss  
to Historic Buildings:  
Final Report

Part 2  
Appendices

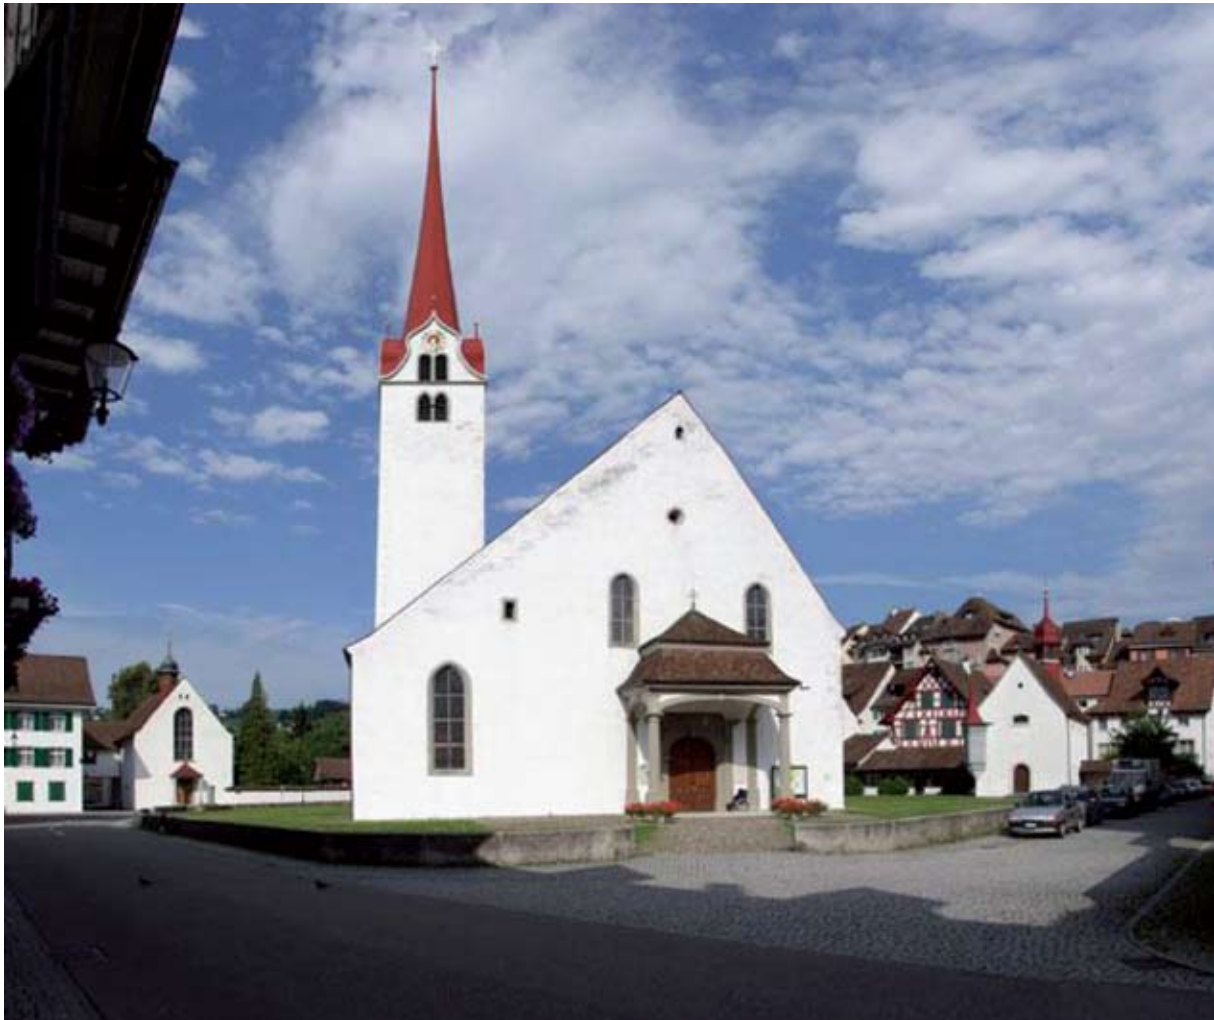
Am 28. März 1984 geriet die Kirche während der Renovationsarbeiten in Brand. Turm- und Kirchendach, Orgel und Orgelempore sowie ein Teil der Altäre wurden ein Raub der Flammen. Die Kirche konnte aber nach den zuvor aufgenommenen exakten Plänen wieder aufgebaut werden. Am 6. Dezember 1987 fand die feierliche Einweihung statt.

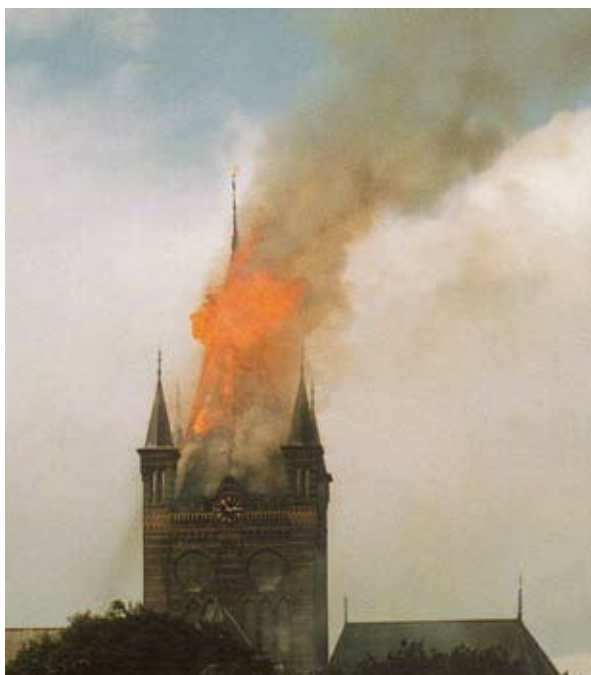
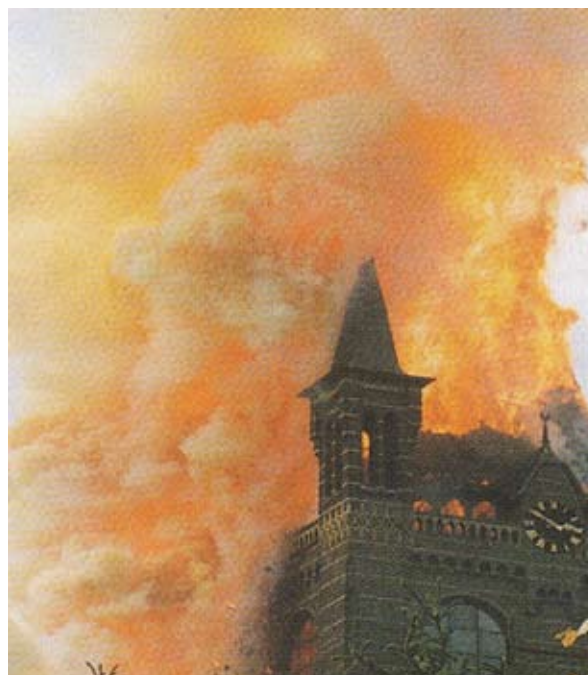
No sprinkler system had been installed in the tower, which meant that the fire services had to tackle the fire from down below. Despite the use of heavy equipment, they were unable to prevent the spire and the tower below from being completely gutted. Parts of the church which had been hit by burning debris had also been extensively damaged. The rest of the building sustained considerable water damage.
